## OUTSTANDING PROJECT AWARD RUNNER UP

# Partnering for Cutoff Wall Project Success

The East St. Louis Deep Cutoff Wall project is located in the area of East St. Louis, Illinois, across the Mississippi River from the city of St. Louis, Missouri, along the left descending bank of the river. The project is a fundamental part of the U.S. Army Corps of Engineers' (USACE) effort to rehabilitate and secure the aging East St. Louis levee system that provides flood protection to approximately 250,000 residents and more than \$4.5 billion in economic value.

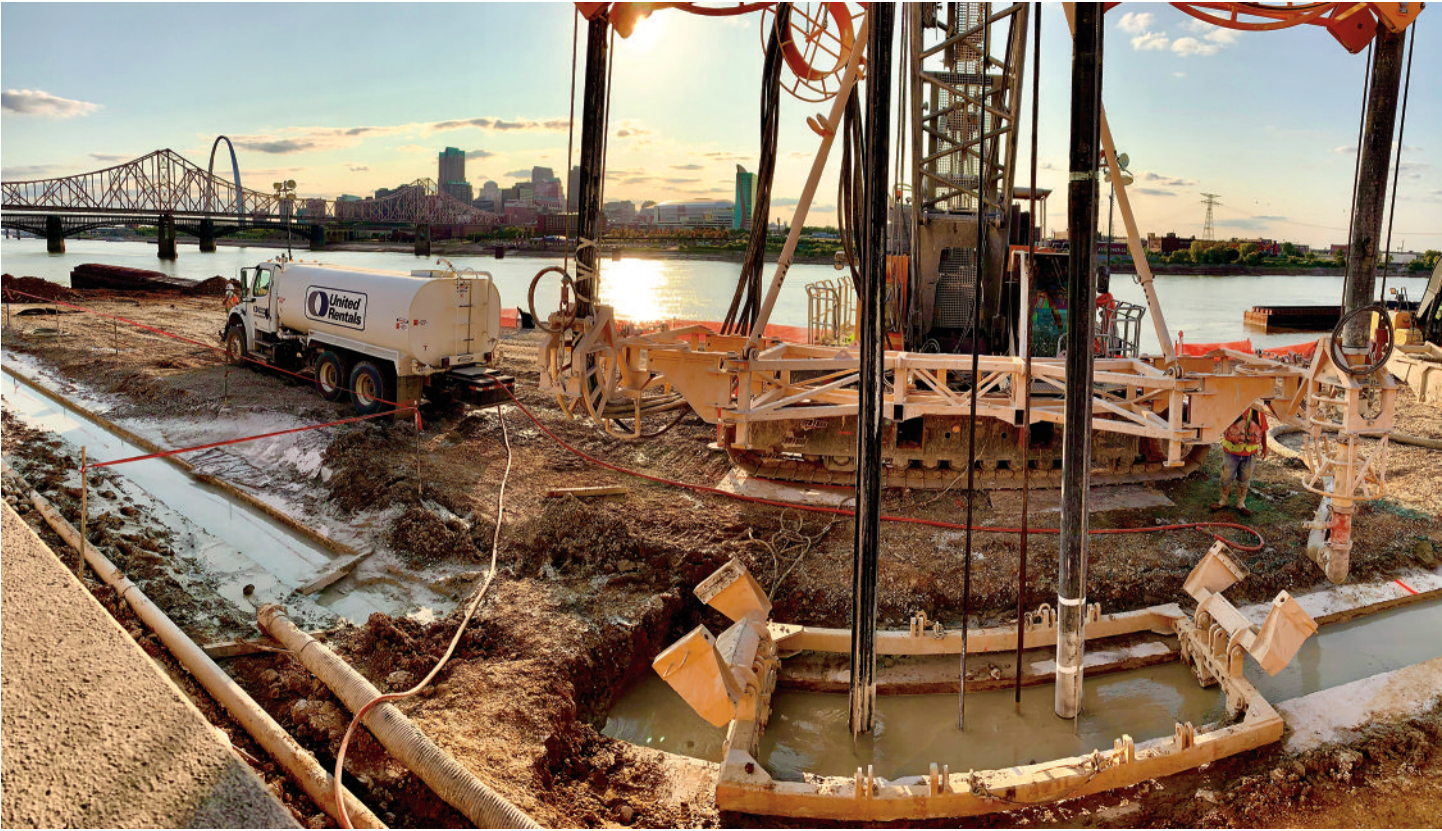
Completed panel excavation at the downstream end of the project

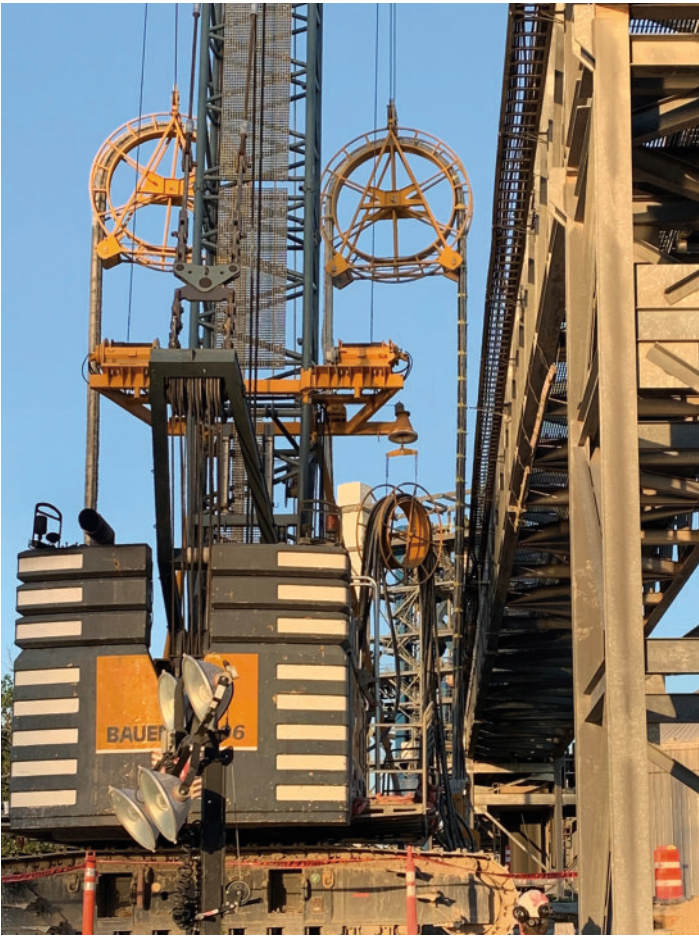
Cutter working in close proximity to a conveyor belt

Several other major utilities crossed — and in some cases ran parallel to — the cutoff wall. Among the many utilities, it is worth mentioning the following: A high-voltage transmission line and a gas pipeline, which ran parallel to the cutoff wall along its entire length and crossed it at the upstream end; a conveyor belt that crossed the cutoff wall to transport grains from storage silos located on the land side of the wall to barges stationed along the Mississippi's shore. Also, a bridge crossed the river, to connect Missouri and Illinois, close to the north end of the cutoff wall.

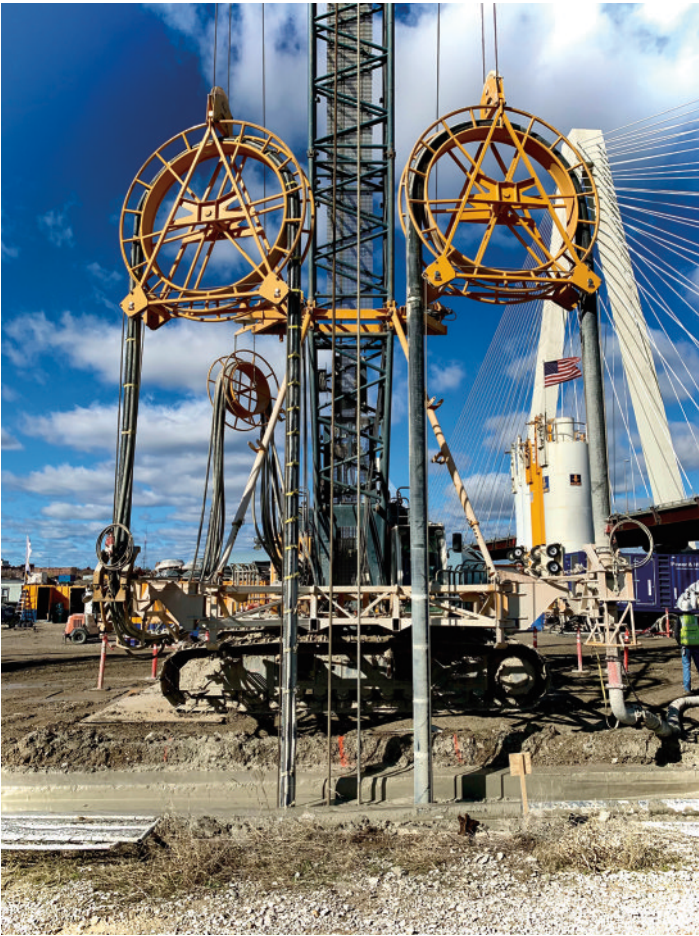
Cutter excavating bedrock at the upstream end of the project (Stan Musial Bridge in the background)

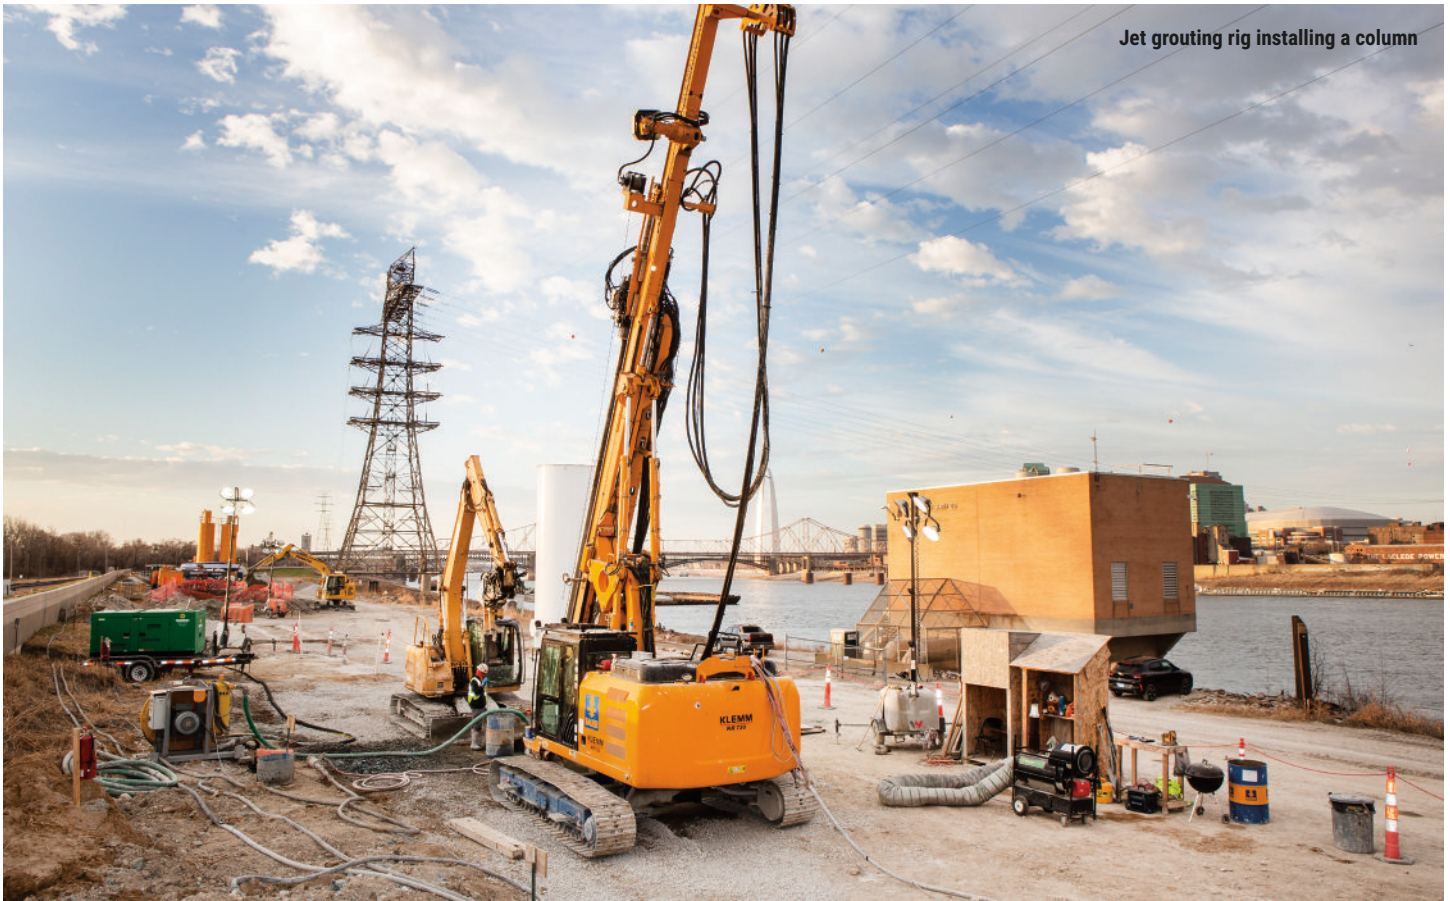
Jet grouting rig installing a column

The contractor decided to make no changes to the cutoff wall installation procedure, given the excellent results previously achieved, and to install the jet grout columns using the single fluid method. The additional cutoff wall panels were installed using the same rigs and batch plant as utilized before. For the installation of the jet grout columns the team mobilized a Klemm KR 720 drill rig and a smaller batch plant that included high-pressure

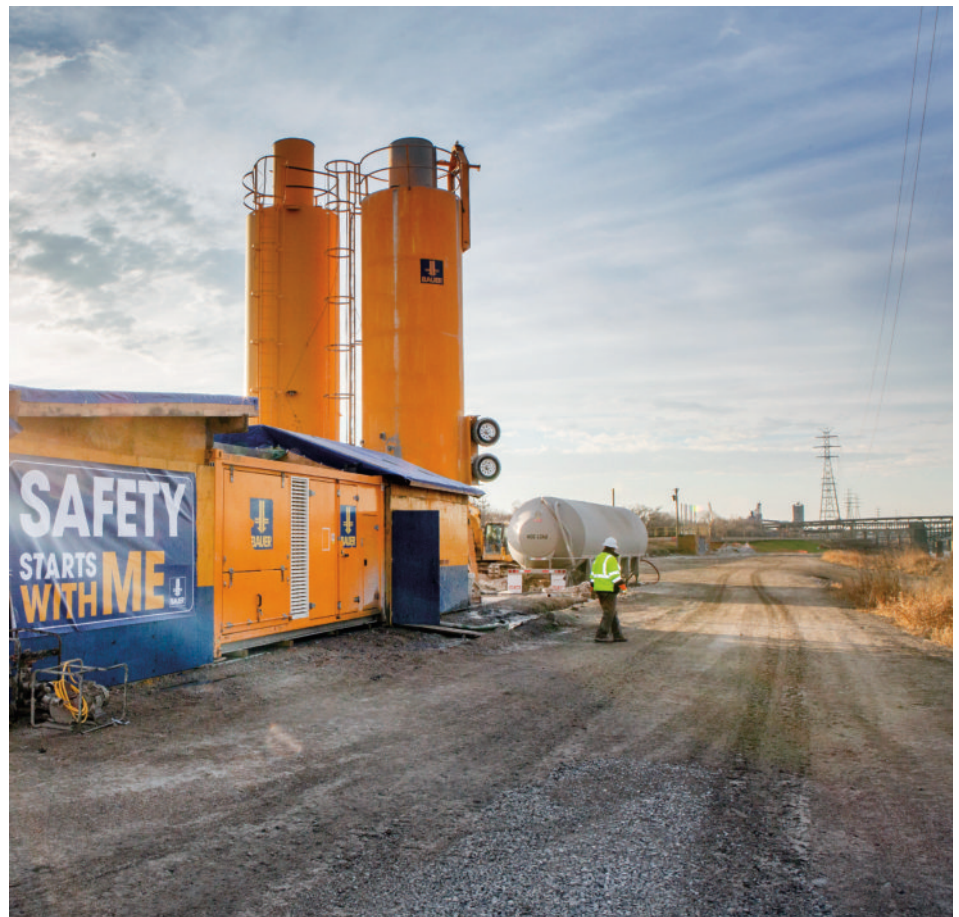
Jet grouting plant

pumps, slurry mixers, and vertical and horizontal silos. Crews installed a total of 167 columns between October 2021 and April 2022.
